SERVICE BULLETIN AR 3201 - 3/92

SUBJECT : Synthesizer Modules AR 3201

Synthesizer Module 28110 - 13000.000
Synthesizer Module 28141 - 13000.000

Ni/Cd-Batteries

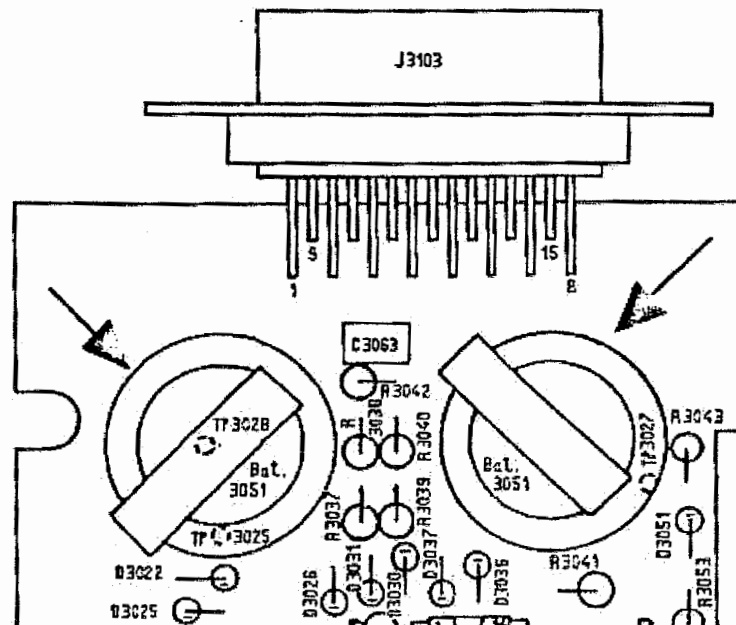
Fig 1: Location of battery Bat. 3051 on Synthesizer Module 28110 - 13000.000

1. Determine manufacturing date of the Ni/Cd-battery. Since 1986 there is a marking on the battery's label (Bat. 3051 and Bat. 3052 or Bat 3001) which describes the manufacturing date.
For example : 8707 means manufacturing date: 7th calendar week 1987
2. If the batteries are more than 4 years old it is recommended to replace the batteries, even if there is no visible damage.
3. Carefully check the battery connectors and the surrounding components for sediments
4. If there are any damages, remove the battery and surrounding components in order to get access to the contaminated printed conductors for cleaning. Use alcohol (methyl alcohol 94%) and a glass-brush for cleaning. Any component removed should be replaced with a new part.
5. If battery replacement is necessary, insert and solder new batteries as shown in Figures 1 to Figure 5.
Ensure correct polarity!

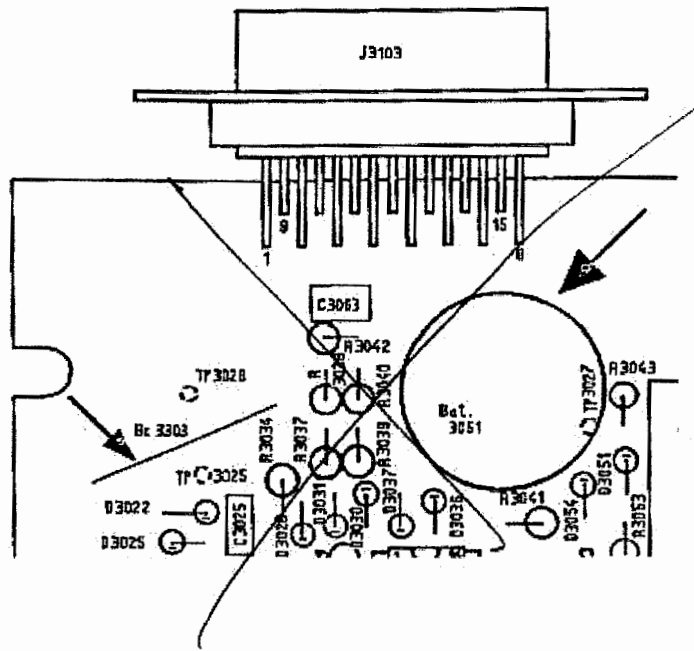
Fig. 2: Location of battery Bat. 3051 on Synthesizer Module 28110-13000.000 Change Index "b"

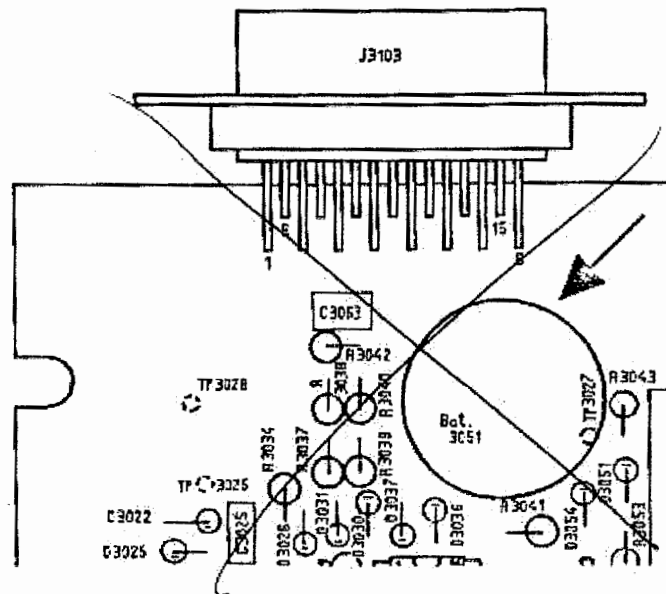
Fig 3: Location of Bat. 3051 on Synthesizer Module 28110 - 13000.000 (new lay out)

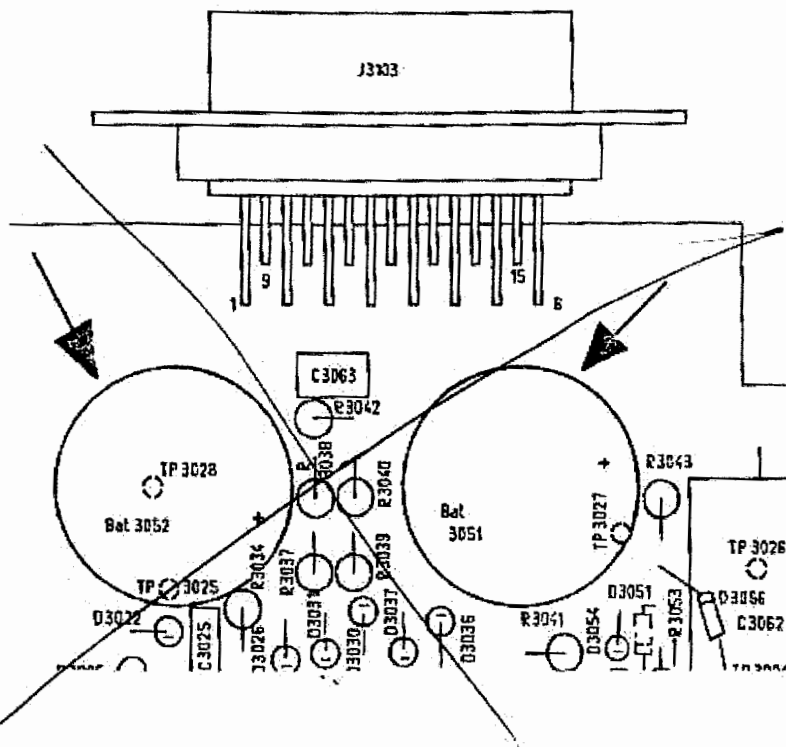
Fig. 4: Location of batteries Bat. 3051 and 3052 on Synthesizer Module 28110-13000.000 Change Index "e"

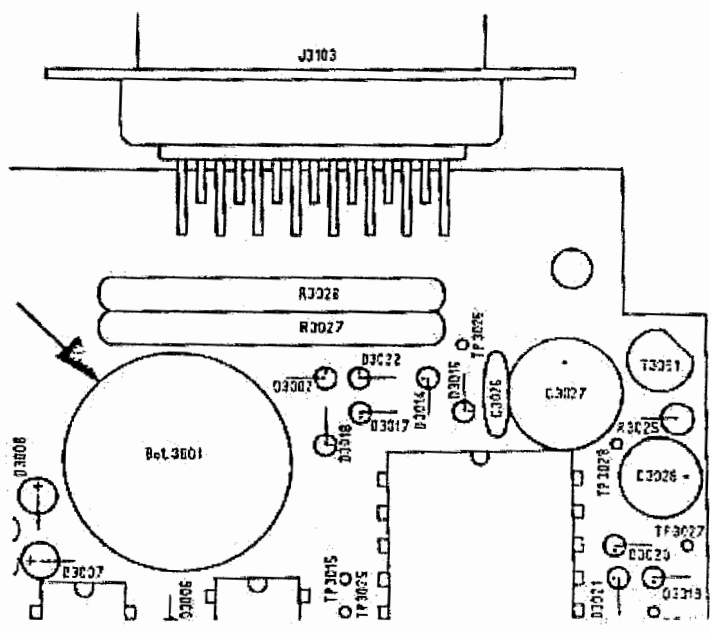
Fig. 5: Location of battery Bat. 3001 on new Synthesizer Module 28141 - 13000.000
